RE: Progress report for March 2008 activities - Hecla Mining Company Apex Site (EPA  
ID No. UT982589848, Docket No. RCRA-8-99-06)

**SUBJECT:** Progress Report No. 47 for period ending March 31, 2008;  
Pond 2 Final Closure - Apex Site, Washington County, Utah

Re: Summary of Revegetation Efforts to Date at Apex Site

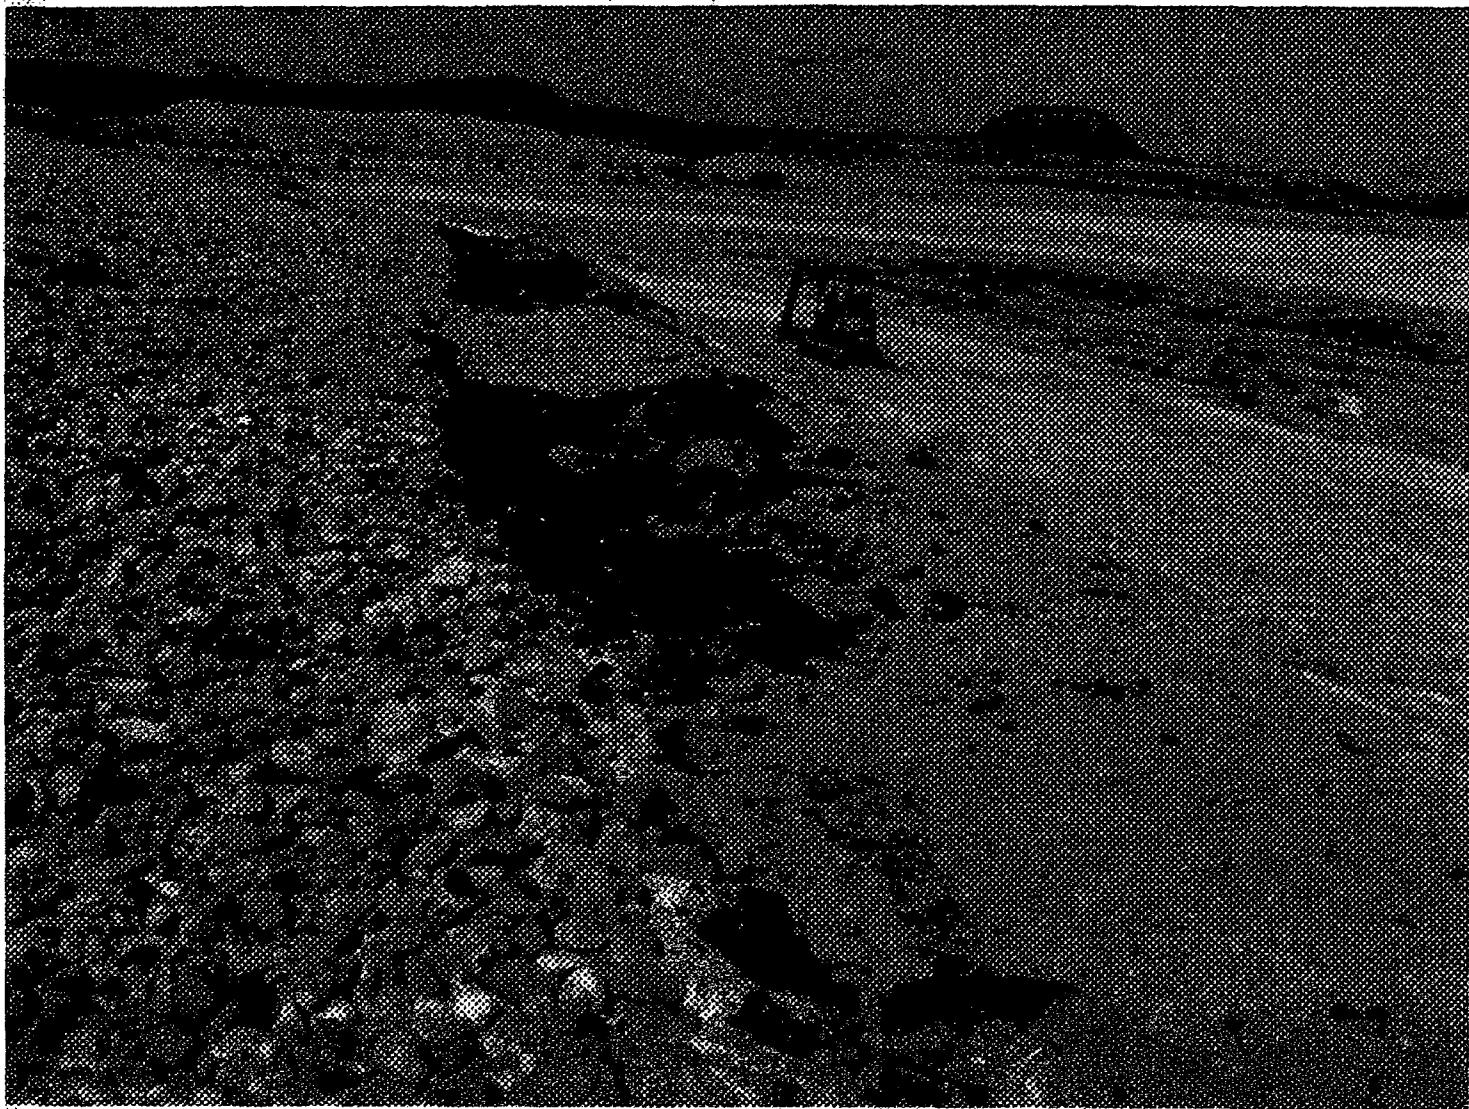
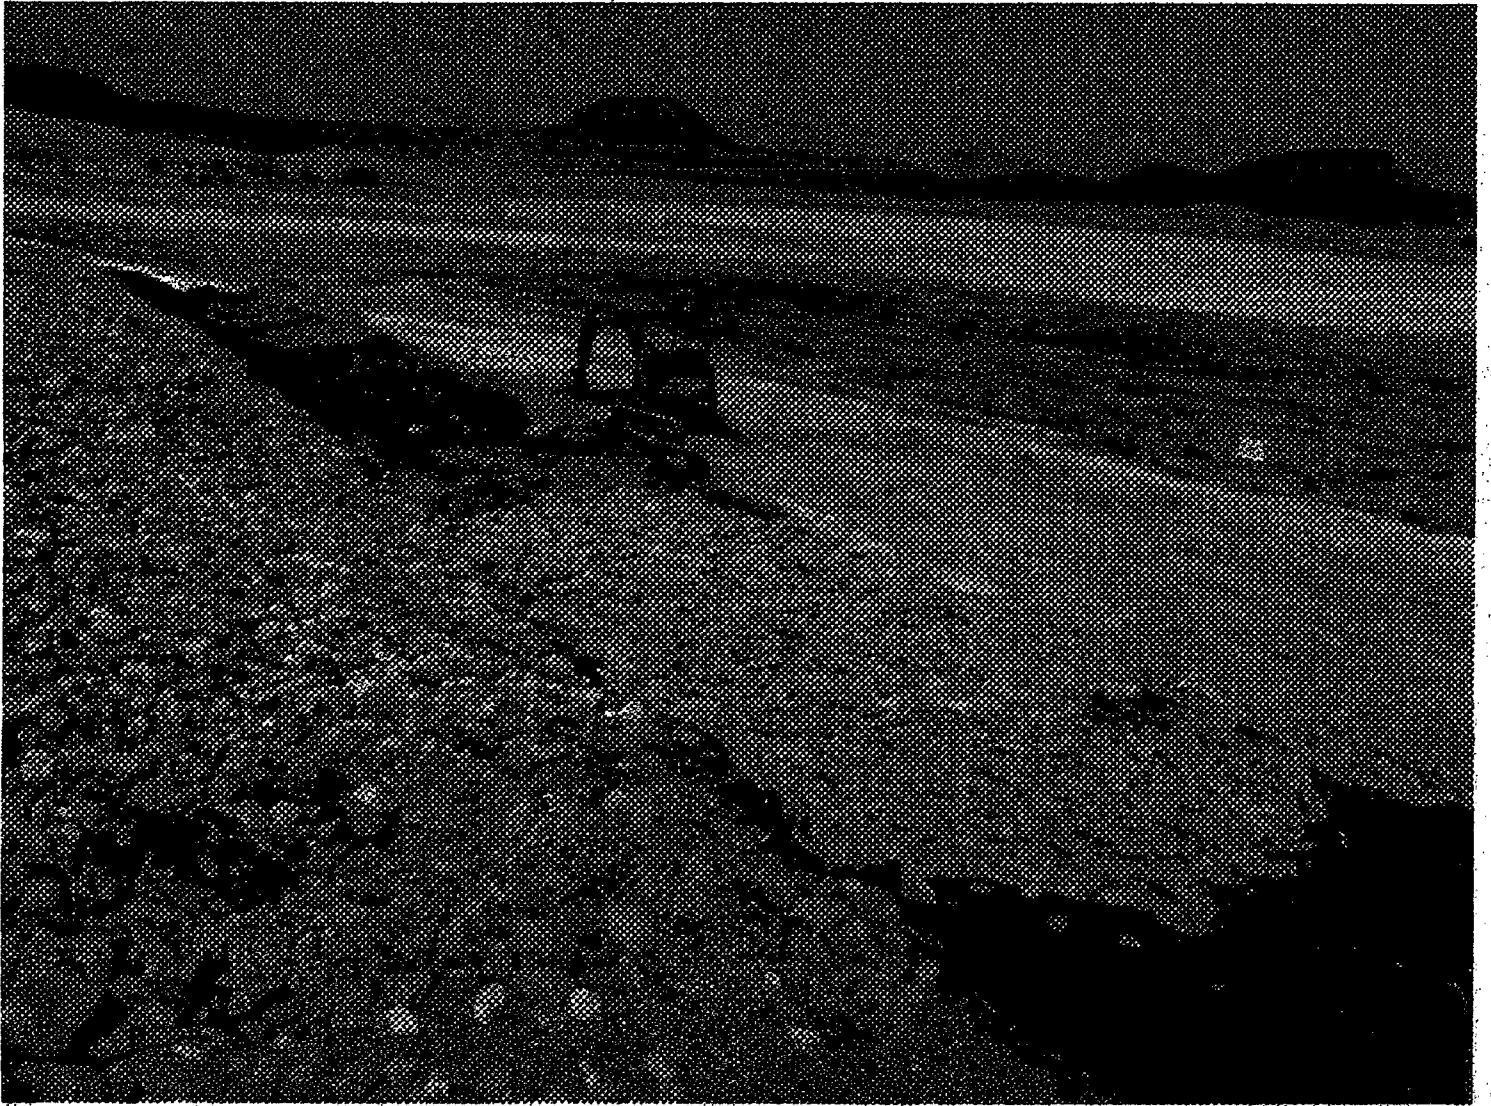
1. Erosion repair photos, by D. Gibbs, MEI.

Erosion repair was started March 19 and concluded March 21 (see attached photos). The primary area of repair was the northern edge of the area. Imported riprap was used to armour the lower slope to prevent future erosion. Doug Gibbs, MEI, was onsite to supervise the work. The work was completed by Desert Hills Construction.
